Re: **Notice of Violation (NOV)**
Bradley Concrete Co, Inc.
NPDES Permit Tracking Number: TNG110384
1500 Lauderdale Memorial Highway
Bradley County, Tennessee

On August 19, 2016, Jennifer Dulin and Michael Bascom of the Division of Water Resources (DWR) conducted a Compliance Evaluation Inspection (CEI) of the above referenced facility. The purpose of the inspection was to evaluate Bradley Concrete Co, Inc. compliance with the terms and conditions of its National Pollution Discharge Elimination System (NPDES) Permit, NPDES Permit Tracking Number TNG110384.

Photographic Log

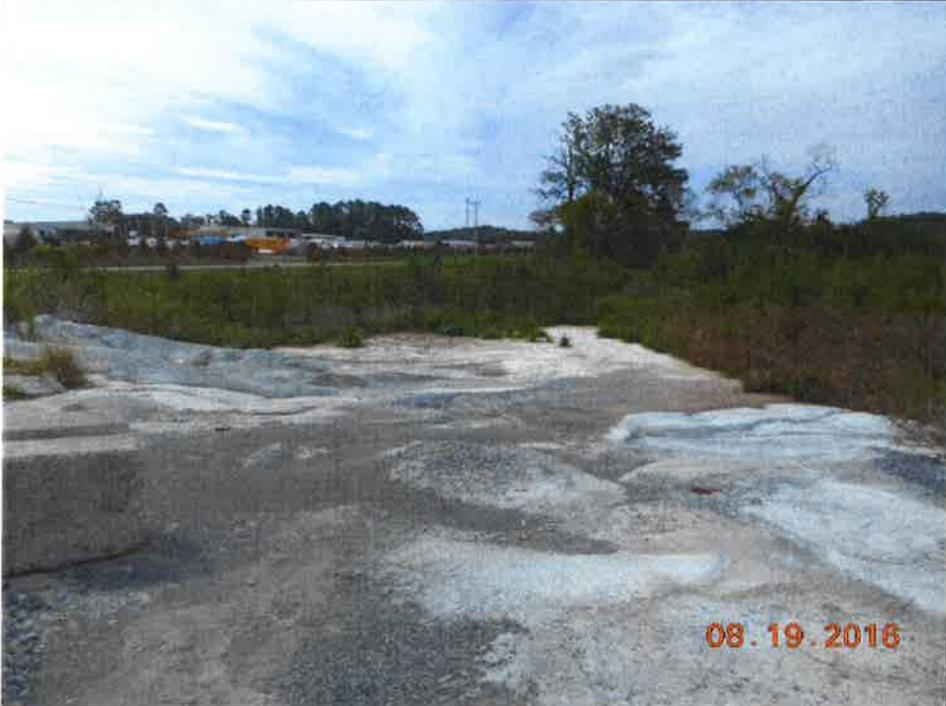
Facility Name: Bradley Concrete Co, Inc.		Site Location:	NPDES Tracking No.: TNG110384
Photo No. 1	Date August 19, 2016

Bradley Concrete Co, Inc. is a Ready-Mixed Concrete Plant, SIC code 3273, located in Bradley County. The physical location of the facility is on Haney Road NW. DWR observed concrete waste had been dumped along the south/southeast side of the property and allowed to migrate off site (Figures 1 and 2).

Description Waste Concrete Allowed to Migrate off Site at the South Side of the Property.

If the facility returns to operation, BMPs must be utilized to prevent waste from leaving the site.

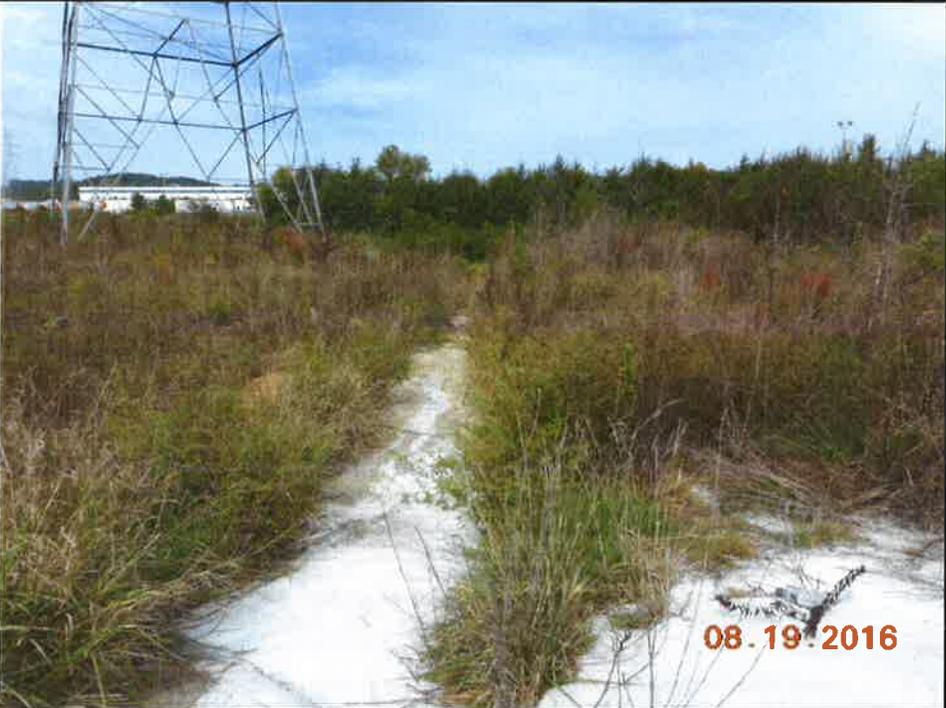
Photo No. 2	Date August 19, 2016

Description Waste Concrete and Debris Migrating off Site at the South End of the Facility.
